First Five-Year Review Report

Dixie Auto Salvage (Non-NPL) Site

Danville
Vermilion County, IL

May 2003

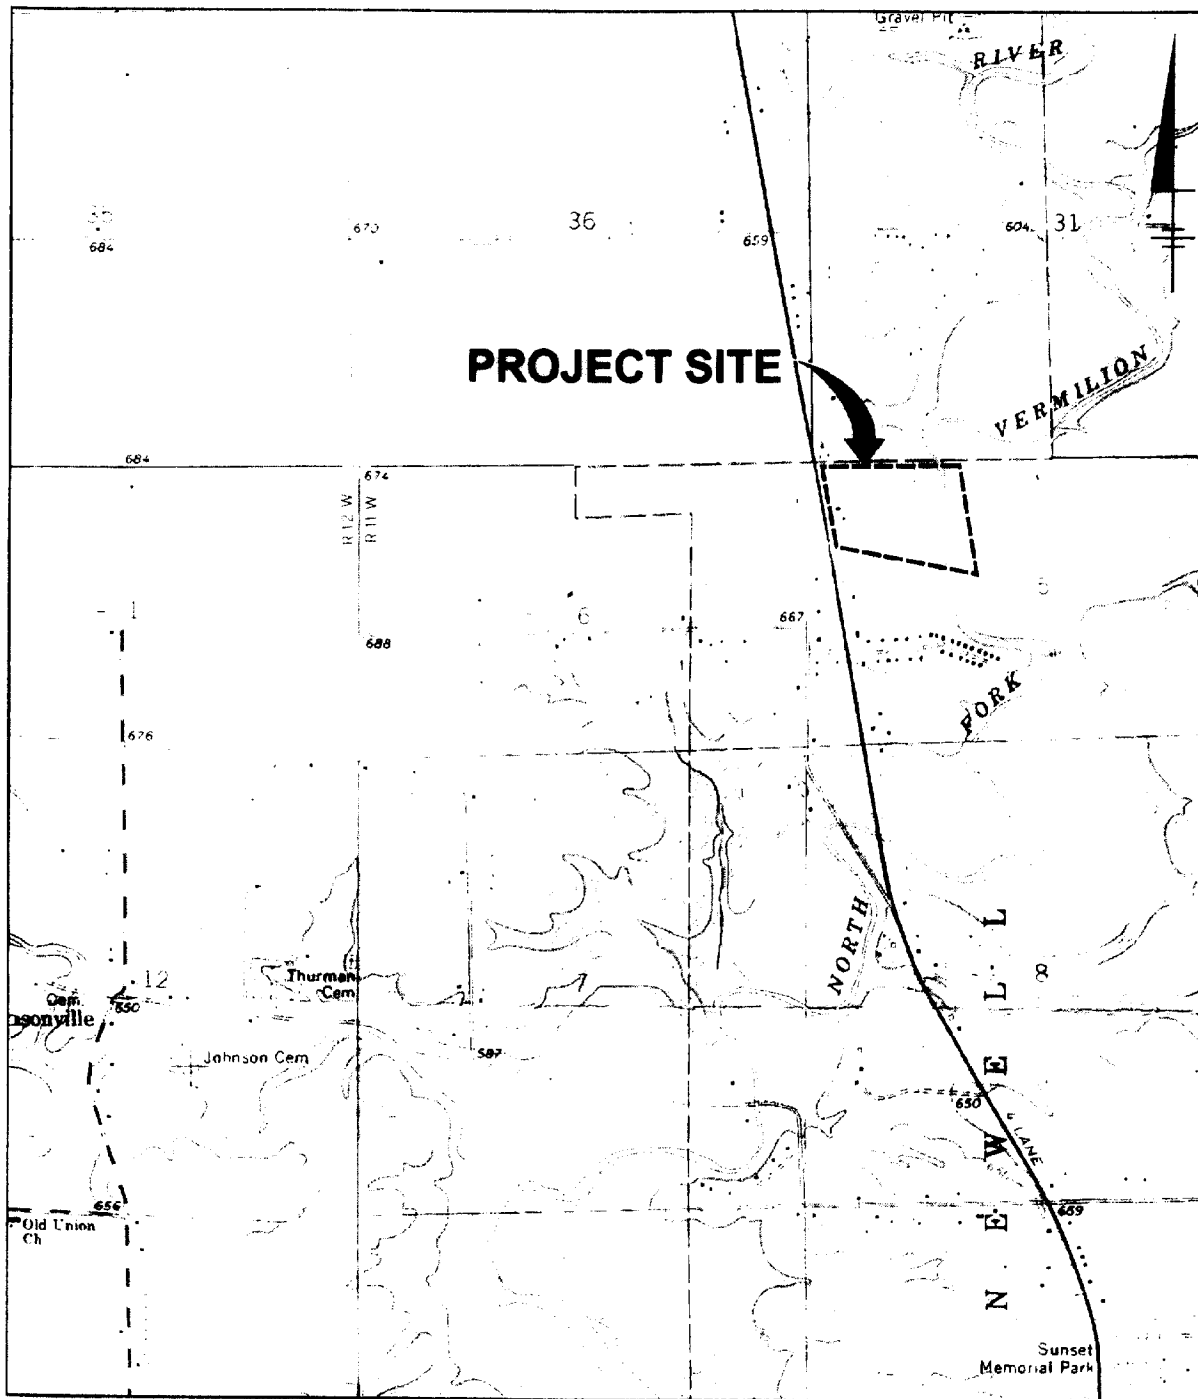
FIGURE
1

REFERENCE: BASE MAP USGS 7.5 MIN. QUAD. DANVILLE NW, ILL., 1978.

The DAS site is a 15-acre property located at 24455 State Route 1, about 3 miles north of Danville, Vermilion County, Illinois (see Figure 1). The site is a semi-rural, partially-wooded residential lot adjacent to the North Fork of the Vermilion River. During the 1960's and 1970's, a former owner of the property operated the Dixie Auto Salvage Yard at which he allegedly burned numerous materials, such as auto parts, wire, and small lighting capacitors, to recover metals for resale. The former owner also dumped the small capacitors and other items that contained hazardous materials, such as lead and PCBs, into several on-site ravines as fill material (along with tree stumps, etc.). Asphaltic wax material derived from the same source as the capacitors was also disposed of at the site. In mid-1960, a large fire within the ravine fill area caused a substantial quantity of the asphaltic wax material to melt and then flow from the ravines towards and partially into the Vermilion River.
